**Flood Control Project Maintenance
Levee Inspections**

Fall 2012 Levee Maintenance Deficiency Summary Report

Reclamation District No. 2058 Pescadero

Waterway			Bank	Unit Miles
Unit No. 01 Paradise Cut			Left	6.71
	Spring (March - May)	Summer (June - August)	(September - November) Fall	Winter (December - February)
Unit Maintenance Rating (Fall Only)			A	
Date of Inspection	03/28/2012 - 03/28/2012		11/06/2012 - 11/06/2012	
DWR Inspector	Jim Eto		Maksim Khashchuk	
Accompanied By	Greg Pombo		Greg Pombo

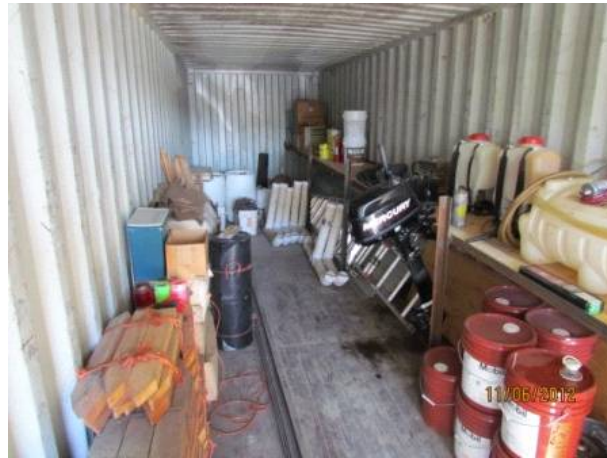
Levee Mile Report Line	2
Start Levee Mile	
End Levee Mile	
Location	Land Side
Category	Earthen Levee
Item	Emergency Supplies & Equipment

View of flood fight supplies.

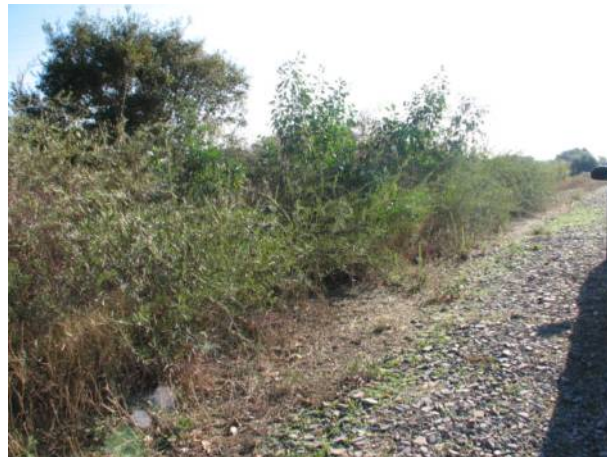
Levee Mile Report Line	4
Start Levee Mile	0.42
End Levee Mile	0.42
Location	Water Side
Category	Earthen Levee
Item	Vegetation

11/08/2011 Thick brush in this area needs to be taken back to 20' from hinge point.

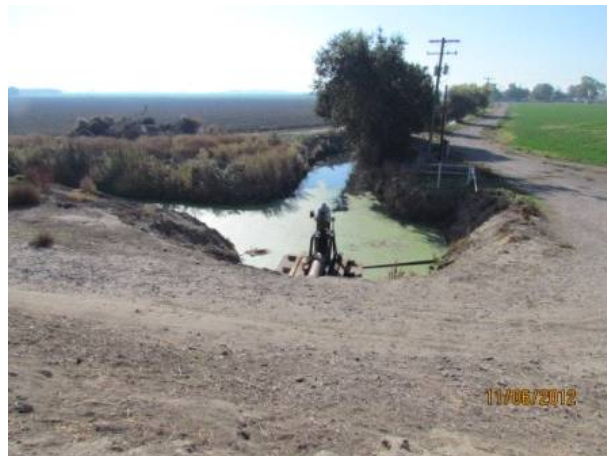
Levee Mile Report Line	5
Start Levee Mile	0.73
End Levee Mile	0.73
Location	Land Side
Category	Earthen Levee
Item	Encroachments

View of discharge pipe on landside slope.

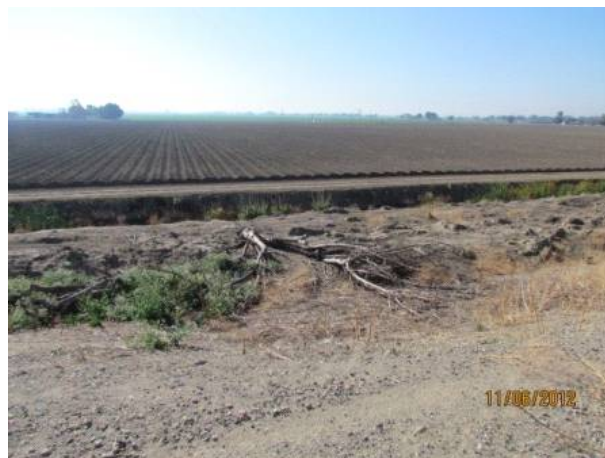
Levee Mile Report Line	6
Start Levee Mile	0.96
End Levee Mile	0.96
Location	Land Side
Category	Earthen Levee
Item	Encroachments

View of prunings on landside slope.

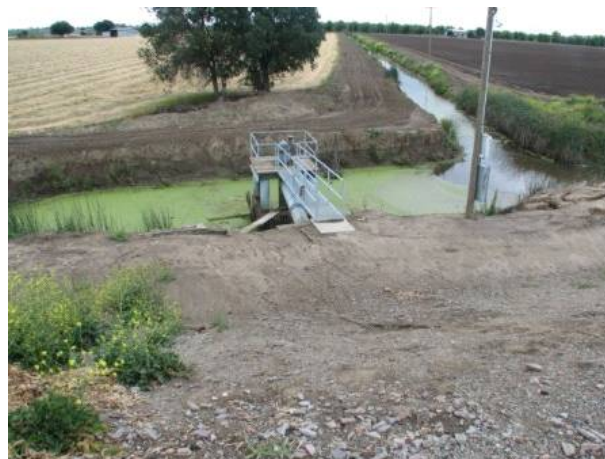
Levee Mile Report Line	7
Start Levee Mile	1.24
End Levee Mile	1.24
Location	Crown
Category	Earthen Levee
Item	Encroachments

Drainage discharge to Paradise Cut.

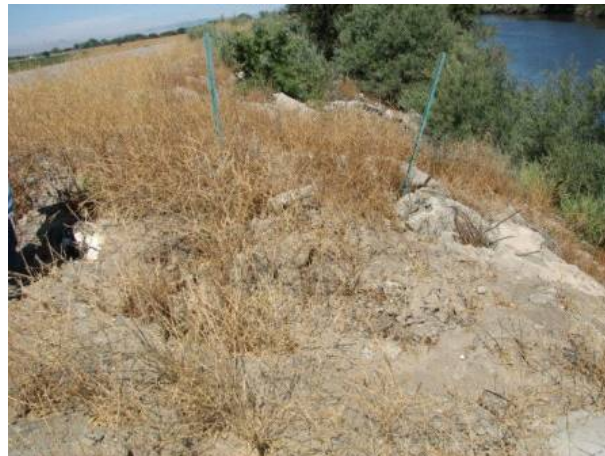
Levee Mile Report Line	9
Start Levee Mile	2.15
End Levee Mile	2.15
Location	Water Side
Category	Supplemental
Item	DWR Erosion Survey

LMR No.	Levee Mile		Category	Item	Location	Rating	Action/Comment	GPS Latitude/Longitude		Issue No.
	Start	End						Start	End	
9	2.15	2.15	Supplemental	DWR Erosion Survey	WS	M Ma	Inspector Comments: 07/31/2012: Site was visited on 07/26/2012. No significant change observed. A new vertical pipe was installed and concrete blocks left on the site. Dense vegetation around the site. No signs of new leaks or spill from the siphon breaker. 09/02/2011: Site was not visited due to the time limit. 09/22/2010: No significant changes observed. Vegetation downstream, upstream and on the lower slope of the site have been recently sprayed. These areas were also fenced off during the site visit, making it difficult for us to examine the condition of the lower slope. Possible leak or spill from the siphon breaker is creating notches along the slope and developing into a headward erosion. If the problem continues, it will erode the slope and fully expose the pipe to outside elements. 07/23/2009: A possible leak or spill from a siphon breaker is eroding the slope and developing into a headward erosion; a portion of the buried pipe is exposed; the lower slope seems to be lined with chunks of concrete debris or other rock material. [2012 Site ID:RD2058U01RM1.78]	37.803769 ° -121.386341 °	37.803769 ° -121.386341 °	1 Y

Close look at the site. Note the concrete blocks and vegetation.

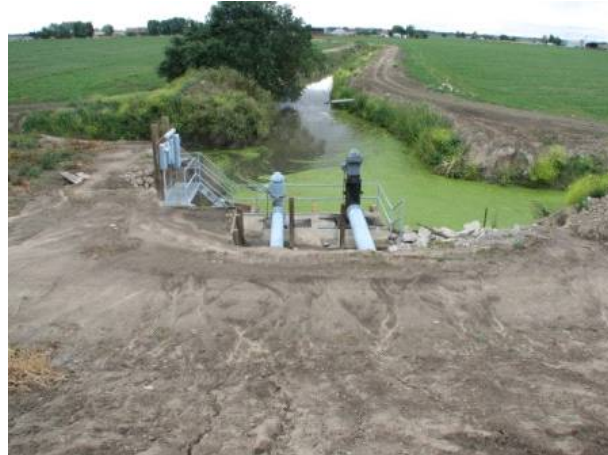
Levee Mile Report Line	10
Start Levee Mile	2.15
End Levee Mile	2.15
Location	Crown
Category	Earthen Levee
Item	Encroachments

Drainage discharge to Paradise Cut.

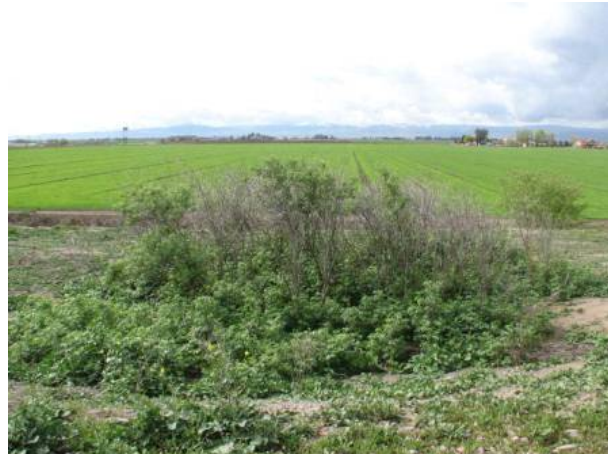
Levee Mile Report Line	11
Start Levee Mile	2.42
End Levee Mile	2.42
Location	Land Side
Category	Earthen Levee
Item	Vegetation

03/28/2012 Large elderberry bush on landside slope.

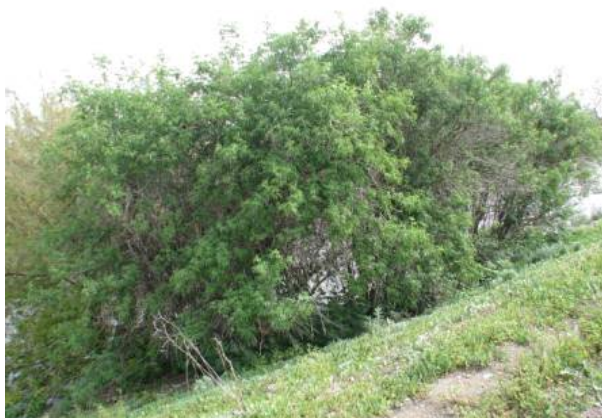
Levee Mile Report Line	12
Start Levee Mile	2.64
End Levee Mile	2.64
Location	Water Side
Category	Earthen Levee
Item	Vegetation

03/28/2012 Large elderberry bush located on waterward slope.

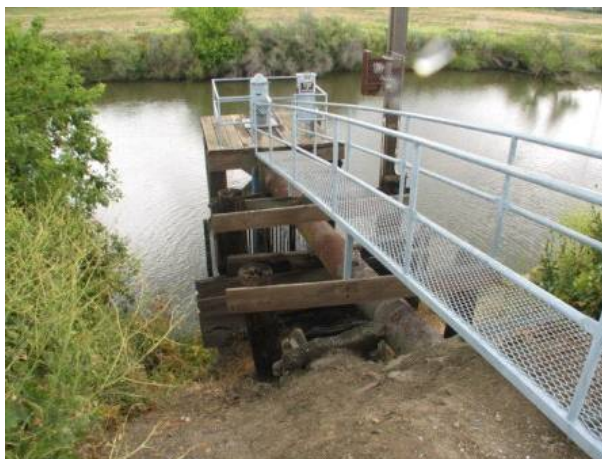
Levee Mile Report Line	16
Start Levee Mile	2.89
End Levee Mile	2.89
Location	Water Side
Category	Earthen Levee
Item	Encroachments

Irrigation intake from Paradise Cut.

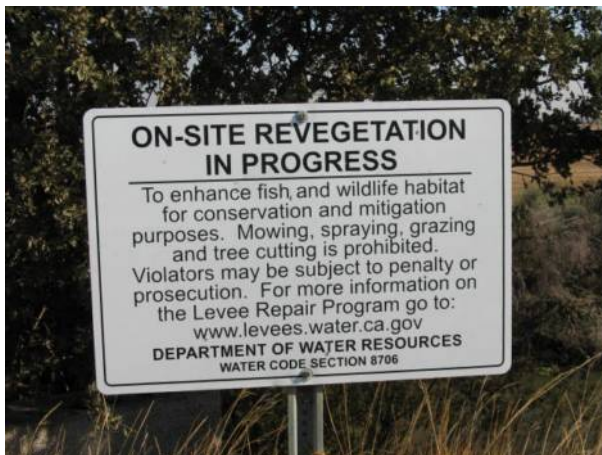
Levee Mile Report Line	21
Start Levee Mile	3.85
End Levee Mile	3.85
Location	Water Side
Category	Earthen Levee
Item	Vegetation

11/08/2011 Revegetation site, cannot trim or cut vegetation in this area.

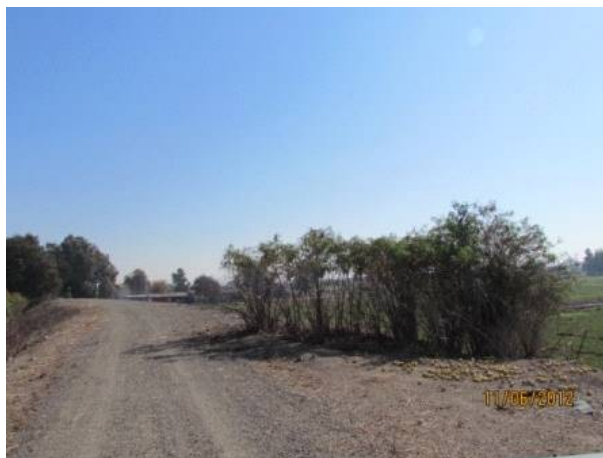
Levee Mile Report Line	22
Start Levee Mile	4.01
End Levee Mile	4.01
Location	Land Side
Category	Earthen Levee
Item	Vegetation

22	4.01	4.01	Earthen Levee	Vegetation	LS Ma	V4 : Elderberries are blocking visibility and flood fight capability. Inspector Comments: Elderberry on landside hinge point.	37.789128 ° -121.361042 °	37.789128 ° -121.361042 °	26 Y
DWR ID: DWR_RD2058_01_s_2012_26									
23	4.01	4.01	Earthen Levee	Vegetation	WSA/W Ma	V4 : Elderberries are blocking visibility and flood fight capability.	37.789096 ° -121.360966 °	37.789096 ° -121.360966 °	69
DWR ID: DWR_RD2058_01_s_2012_69									
24	4.36	4.36	Earthen Levee	Vegetation	WSA/W Ma	V4 : Elderberries are blocking visibility and flood fight capability.	37.789794 ° -121.354883 °	37.789794 ° -121.354883 °	71
DWR ID: DWR_RD2058_01_s_2012_71									
25	4.49	4.53	Supplemental	DWR Erosion Survey	WS Ma	Inspector Comments: 07/26/2012: The site has been visited, and no significant change has been observed. 09/02/2011: This site was not visited due to the time limit. 09/22/2010: No significant changes observed. Minor pocket erosions are lined at the lower bank. Two large Oak and Willow trees are on midslope and bench. The remaining bench was re-measured and found to be approximately 10 feet. There was no indication of active erosion on site during the site visit. 08/05/2010: Recommended for annual assessment and monitoring of site during flood events, per CLRO. 07/23/2009: No major change observed since last visit; site is a 200-ft. long near-vertical berm erosion; recommend annual assessment and monitoring of erosion site, per CLRO CES Evaluation 2008 Report; Site # is the same site previously reported as RM4.0,LM4.51; previously rated "U". 09/10/2008: Two large trees (2-3' DBH) with partial roots exposed. 2007: Visited site 03/13/2007. [2012 Site ID:RD2058U01RM3.97]	37.789810 ° -121.352490 °	37.789810 ° -121.352490 °	2 Y

Elderberry bushes on landside slope.

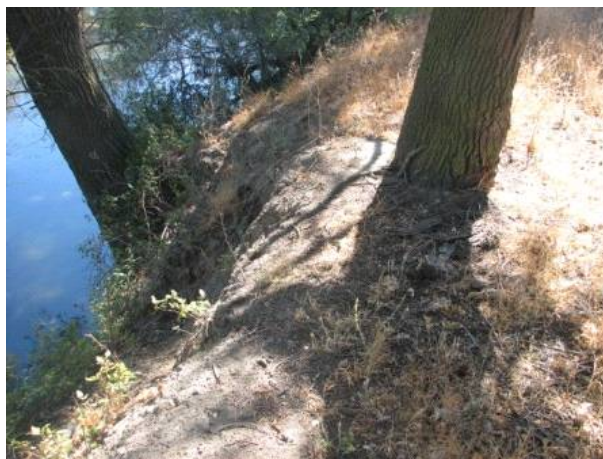
Levee Mile Report Line	25
Start Levee Mile	4.49
End Levee Mile	4.53
Location	Water Side
Category	Supplemental
Item	DWR Erosion Survey

Direct view at a pocket erosion site. Vegetation has developed and covered the erosion.

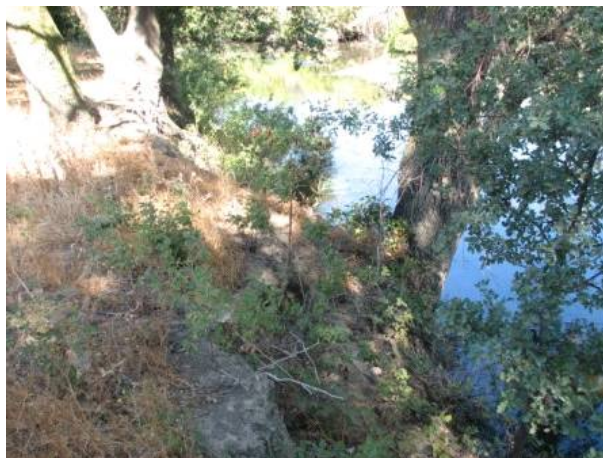
Levee Mile Report Line	25
Start Levee Mile	4.49
End Levee Mile	4.53
Location	Water Side
Category	Supplemental
Item	DWR Erosion Survey

Direct view at a the erosion near a tree

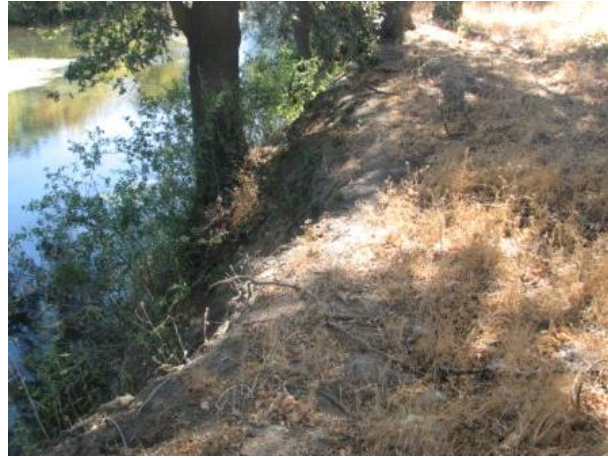
Levee Mile Report Line	25
Start Levee Mile	4.49
End Levee Mile	4.53
Location	Water Side
Category	Supplemental
Item	DWR Erosion Survey

Direct view at a the erosion near a tree

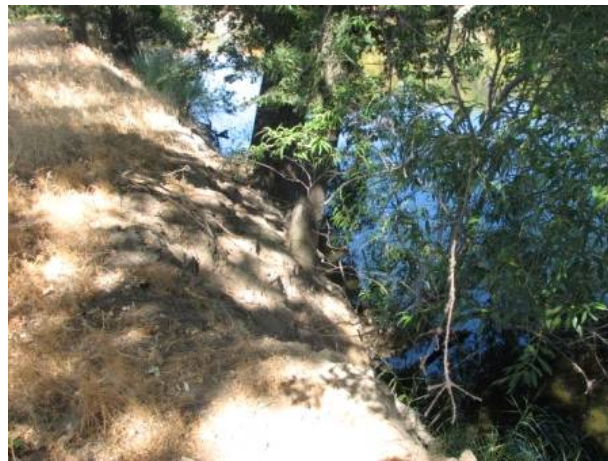
Levee Mile Report Line	25
Start Levee Mile	4.49
End Levee Mile	4.53
Location	Water Side
Category	Supplemental
Item	DWR Erosion Survey

Direct view at a the erosion near a tree

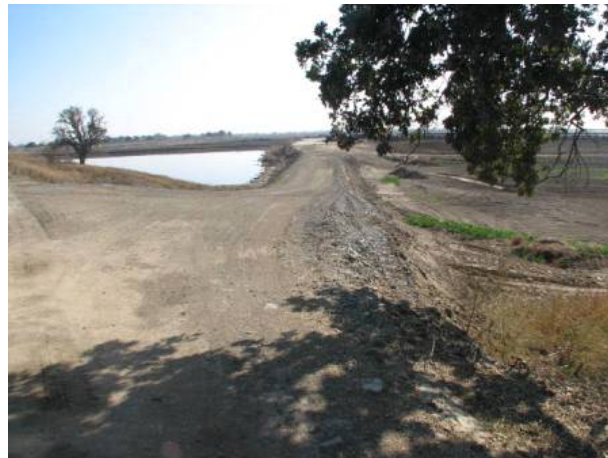
Levee Mile Report Line	26
Start Levee Mile	5.16
End Levee Mile	5.16
Location	Land Side
Category	Earthen Levee
Item	Encroachments

DWR ID:									
26	5.16	5.16	Earthen Levee	Encroachments	LS En	RA : Ramp Inspector Comments: New Ramp construction Connecting Dairy to levee. Construction of ramp results in a new pond on the landside of the levee. 2/21/2012, owner has said that he will contact the CVFPB to resolve this issue.	37.783102 ° -121.345682 °	37.783102 ° -121.345682 °	29 Y
DWR ID: DWR_RD2058_01_s_2012_29

11/08/2011 New ramp has been constructed by Dairy farmer connecting his barns to the levee.

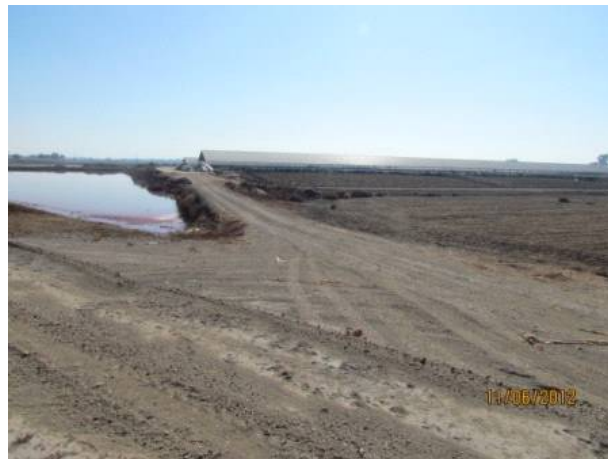
Levee Mile Report Line	26
Start Levee Mile	5.16
End Levee Mile	5.16
Location	Land Side
Category	Earthen Levee
Item	Encroachments

Completed new ramp constructed by Dairy farmer connecting his barns to the levee.

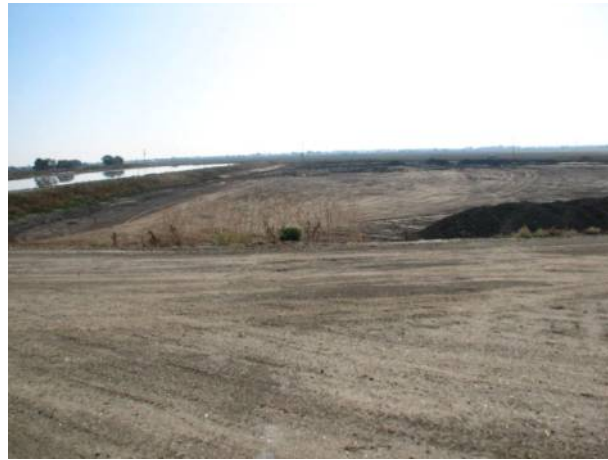
Levee Mile Report Line	27
Start Levee Mile	5.37
End Levee Mile	5.37
Location	Land Side
Category	Earthen Levee
Item	Encroachments

11/08/2011 Photo shows view from the levee looking to the left of the middle ramp.

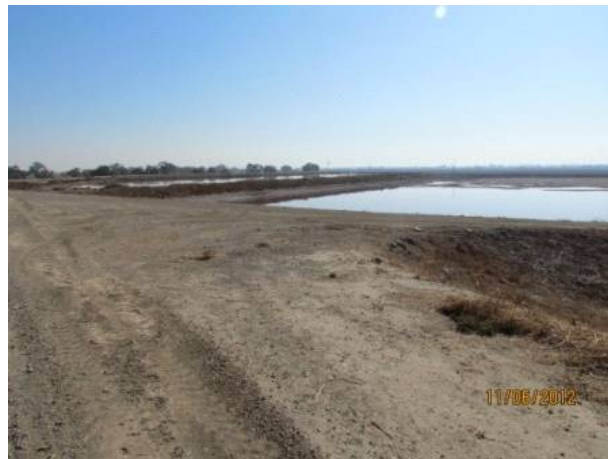
Levee Mile Report Line	27
Start Levee Mile	5.37
End Levee Mile	5.37
Location	Land Side
Category	Earthen Levee
Item	Encroachments

Completed new ramp constructed by Dairy farmer connecting his barns to the levee.

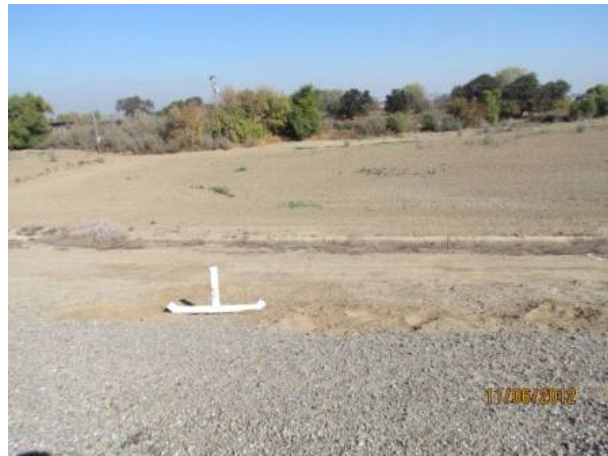
Levee Mile Report Line	28
Start Levee Mile	6.06
End Levee Mile	6.06
Location	Water Side
Category	Earthen Levee
Item	Animal Control

View of rodent burrows on waterside slope.
